**NI 43-101 Technical Report  
San Juan Property  
Arequipa Department  
Peru**

Prepared for:  
**Century Mining Corporation**

19 March 2007  
071421

Prepared by:  
**Chlumsky, Armbrust & Meyer, LLC**

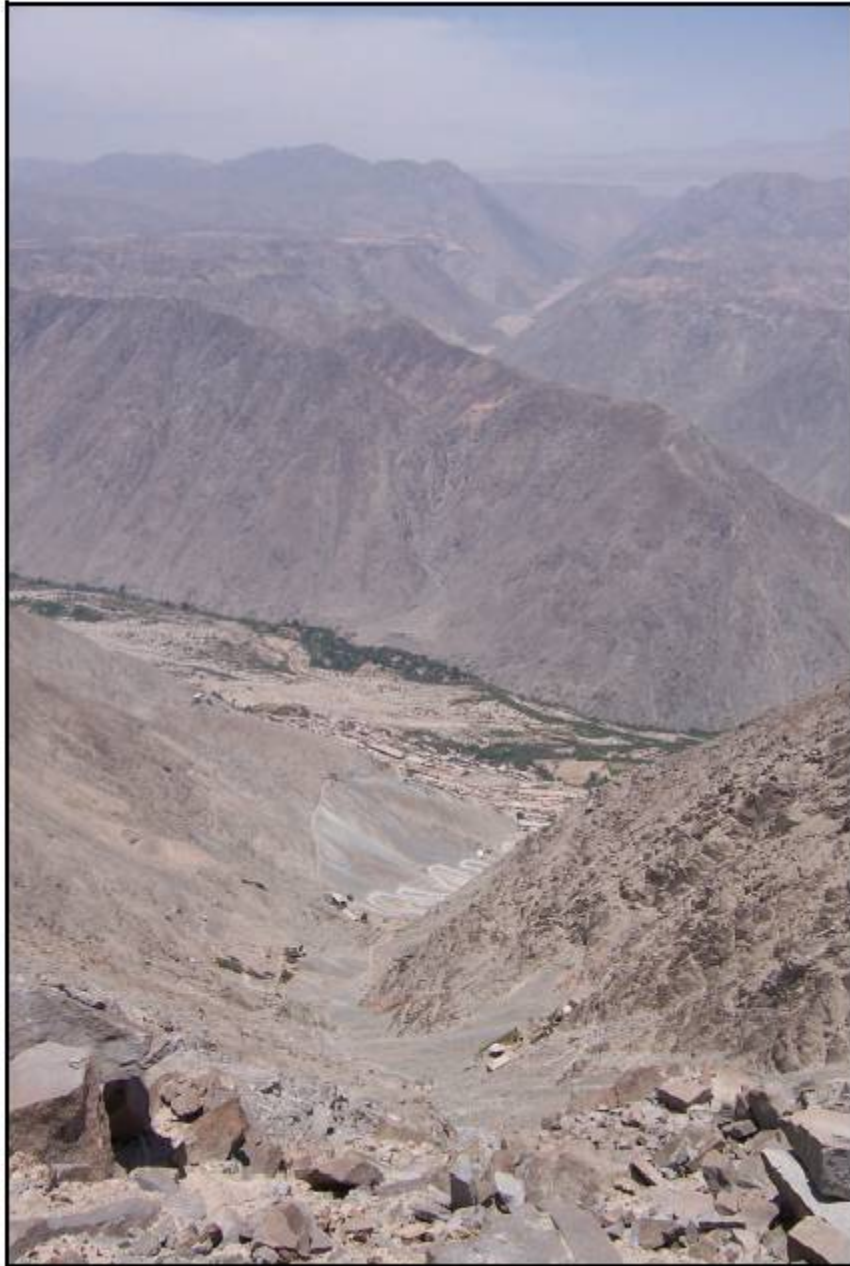
**Figure 3-1**  
**View of San Juan Property**

Figure 3-1 looks south from Pampa las Yeseras across the Chorunga Valley (middle) to the Esbilla Valley in the distance. The winding road reaches the San Juan Mine Level 0, with Level 3.5 and Level 4 visible below the viewer. Steep slopes are underlain by granodiorite and other batholithic rocks, while the flatter surface in mid-distance exposes flat-lying post-mineral volcanics and sedimentary rocks.

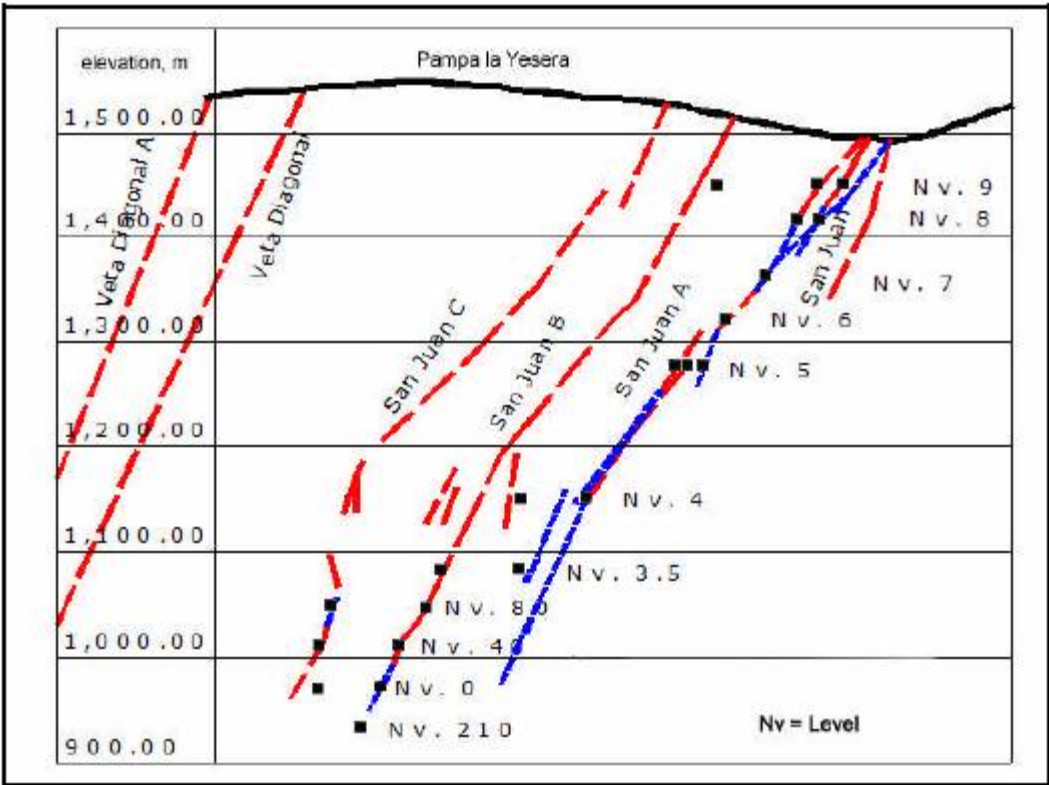
Figure 11-5  
Cross-section through San Juan-Diagonal Vein Group

Figure 11-5 is looking east with no vertical exaggeration. Black squares represent workings (exaggerated size).

Figure 11-3 shows a long section of the eastern part of the San Juan Vein, while Figure 11-4 is a detail of a larger-scale long section on the same vein. Figure 11-5 is a cross-section through the San Juan Vein and several parallel veins (the “Diagonal” group) to the north of the main San Juan Vein.

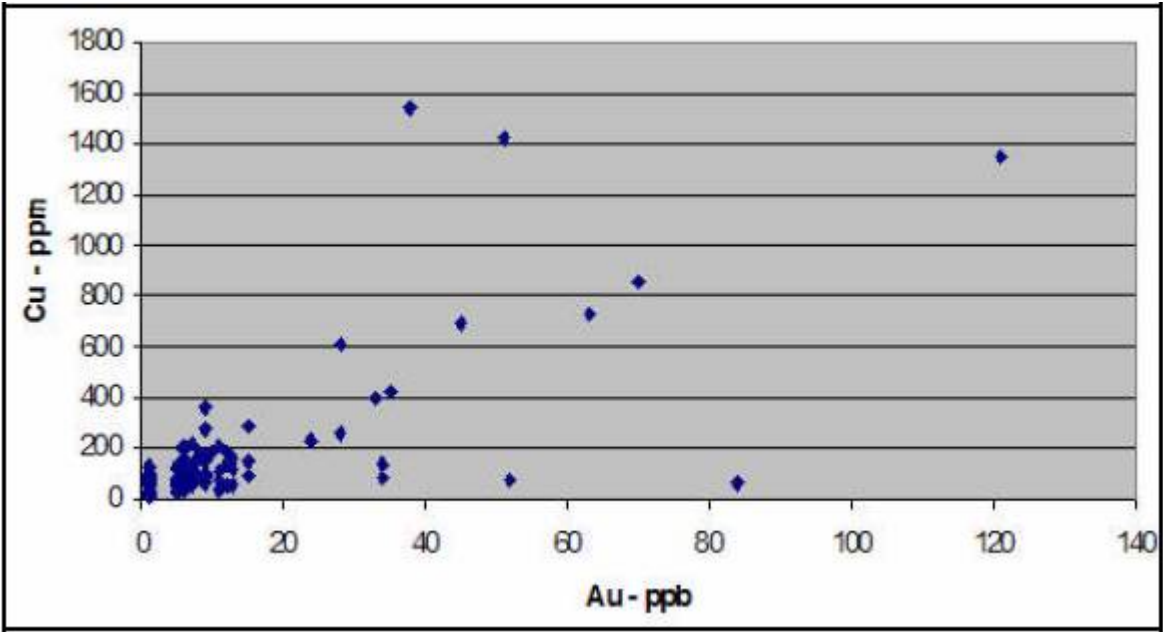
Figure 11-7  
Plot of Au versus Cu values, Champune

Results of 123 surface (oxidized) samples analyzed for Au and Cu are shown graphically in Figure 11-7. Century collected 108 of these samples in 2006; the others are from MIRL and San Juan Gold Mines. This shows that a correlation exists between Au and Cu, but that both are present in low values except for 6 percent of the samples which contained either greater than 600 ppm Cu or 40 ppb Au.

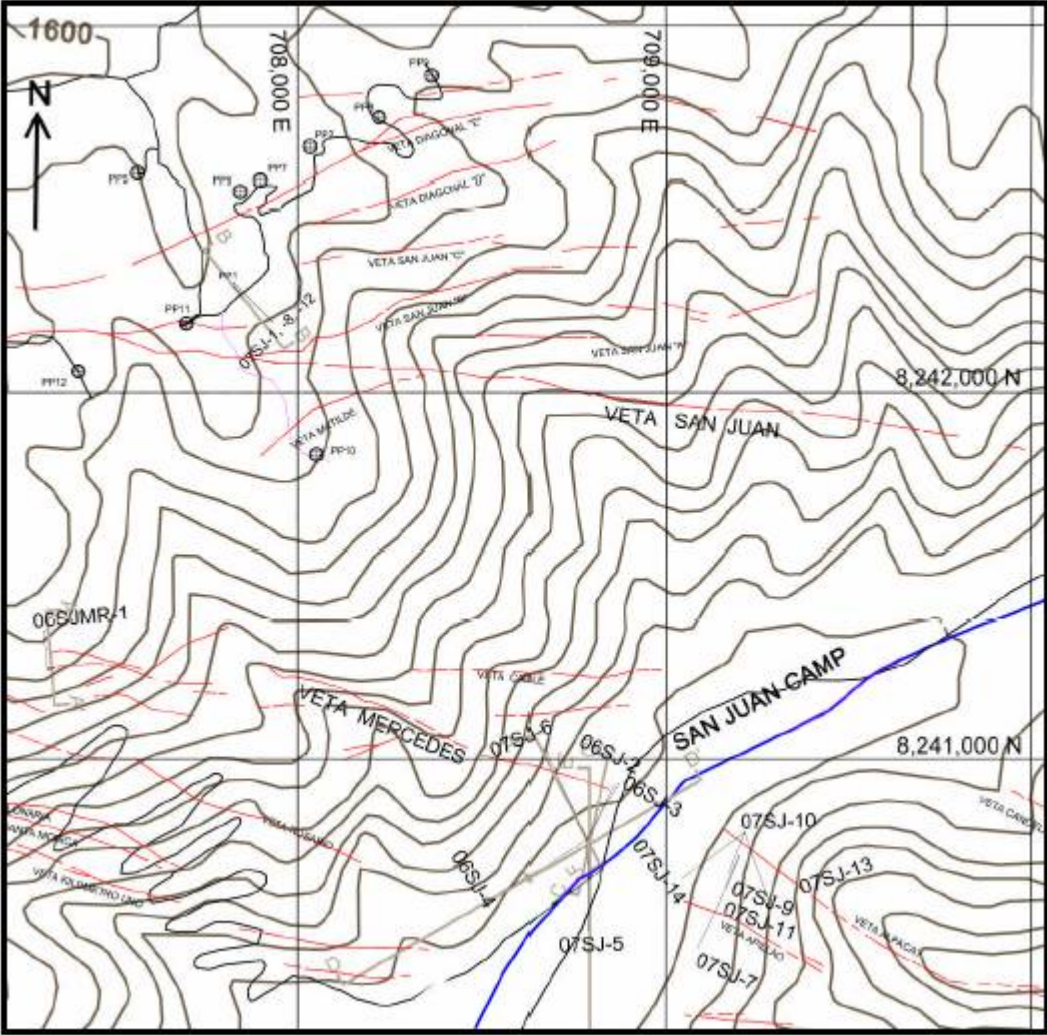
**Figure 22-1**  
**Century Drillhole Locations**

The drilling program below is recommended to seek mineralized extensions of the known veins at depth, and along strike away from the Chorunga Valley. Several of these holes had been completed and assayed at the time of this report, as discussed in section 13 of this report. The targets, which include holes completed since late 2006, are shown on Table 22-1, while hole locations are shown on Figure 22-1.

By mid-February 2007, Century had completed five diamond-drill holes on the San Juan veins. Extracts of results for these holes, as taken from Century press releases dated January 8, January 29, and February 15, 2007, are shown in Table 13-1. Locations of these holes are shown in Figure 22-1.
